Errata Sheet

RV-8803-C7

Silicon Limitation

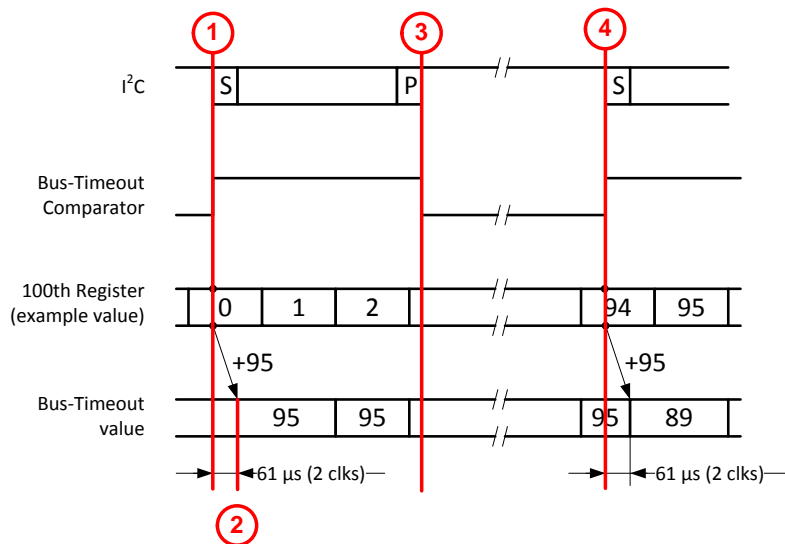
Initialization of the I²C Interface Bus-Timeout by RV-8803-C7:

1. At START condition, the Bus-Timeout Comparator is enabled.
2. It takes 2 clocks 32'768 Hz (61 μs) to read the value of the 1/100th seconds, adding 95/100th and write this as a Bus-Timeout target into the comparator.
3. At STOP condition, the comparator is disabled.
4. At the consecutive START (after STOP), the comparator is enabled with previous Bus-Timeout target value before the next value is calculated and written into the comparator.

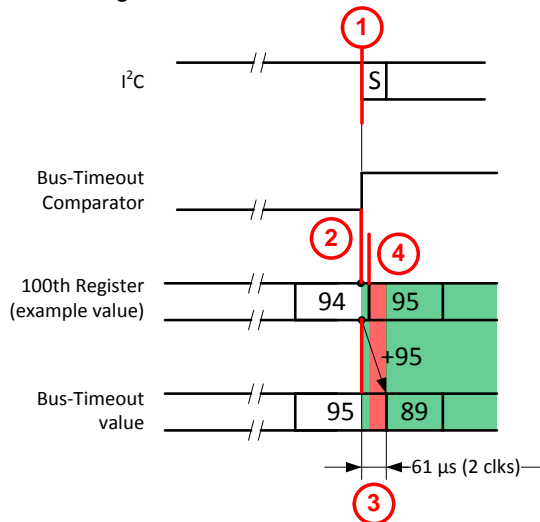
Erroneous Bus-Timeout Reset Scenario 2: New START shortly before 950 ms after previous START

- 1. At START condition, the comparator is enabled.
- 2. At the consecutive START the comparator is enabled with previous Bus-Timeout target value. As long as no match with the current 1/100th second is detected no RESET will be triggered.
- 3. It takes 2 clocks 32'768 Hz (61 μs) to update the new Bus-Timeout target value.
- 4. If during the 61 μs required for up-dating the Bus-Timeout value the 1/100th of Second is incremented and match the previous Bus-Timeout target value, the I²C Interface will be RESET.

Summarized: At START condition of the I²C Interface the Bus-Timeout comparator is enabled. The 1/100th Seconds register might have the value “previous Bus-Timeout value less one” and the RV-8803-C7 will replay with acknowledge. As soon as the there is a match between the current value in the 1/100th Seconds register and the previous set Bus-Timeout value, the comparator triggers an I²C Bus-Timeout RESET and the RV-8803-C7 will reply with “no acknowledge”.

It's recommended to follow I²C standard protocol and check ACK "acknowledge". When "no acknowledge" is detected, repeat communication procedure beginning with I²C Start.

Workaround: Repeat I²C communication procedure maximum 4 x times.
