PRODUCT CHANGE NOTICE

Document ref:	PCN120921A v1.0
Issued:	21 Sep 12
Authorised:	JPG

MS3V

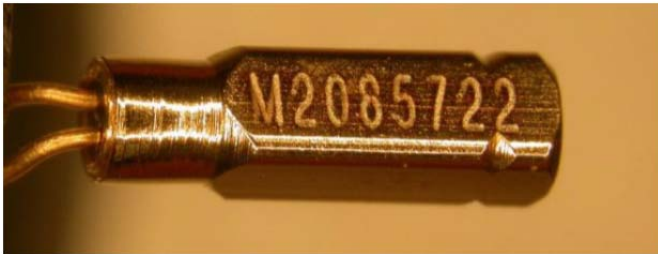
Original plating (Au)

The cap of the existing MS3V part was plated with a Gold flash. In the flow of continuous improvement of our product, several different coating materials have been evaluated. Extensive tests have shown that Palladium (Pd) coated surfaces have a superior behaviour concerning solderability over the present cap flash surface.

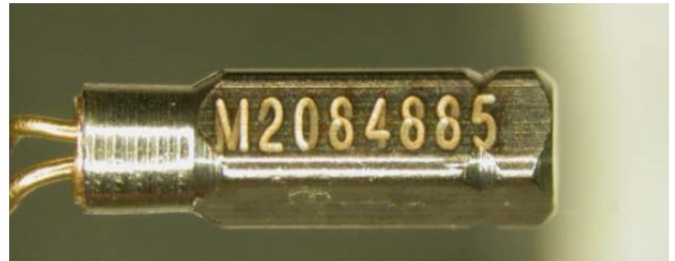
Replacement plating (Pd)

The new surface coating with Palladium has been proven to be equivalent or even superior to the Gold plated surface, so transition should be seamless. Supply of Palladium coated parts will commence in the coming months, once stocks of the original gold-plated parts are depleted. Golledge part numbers will not be changing. No customer action is required.
